MORGAN K. COHEN
HOME INSPECTION LLC

Property Inspection Report

20 Elm St.
Arlington MA

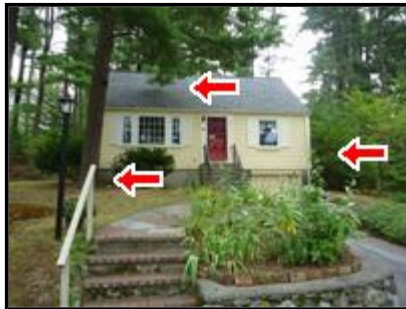
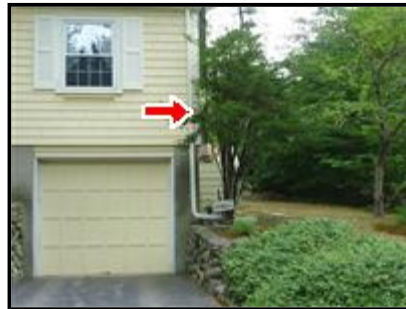
(1) **RR:** Trees and/or shrubs are planted too close or are growing too close to the building. Vegetation can damage the siding, the trim and the roof, and it can clog the gutters. Overhanging tree limbs can allow animals and insects onto the roof or can cause damage to the roof. Roots from trees planted too close to the building can cause damage to the foundation and sewer lines. Areas that are too shady do not allow the siding to dry out and mold, moss, and deterioration can occur. Prune trees and shrubs away from the building. Shrubs should be trimmed at least 18 inches away from the building and trees should be pruned 10 feet from the building. You should seriously consider removal of the large pine tree at the front left corner of the home. Consult a landscape contractor for repair.

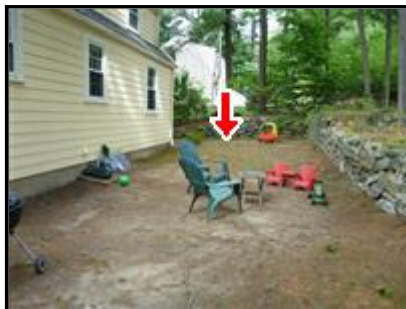
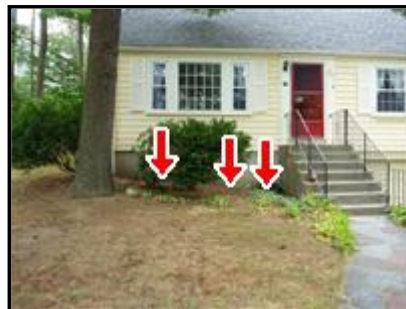
(2) **RR:** There are areas on the left rear corner and next to the front stairs of the home that are level or do not slope away from the building. Improvements to the grading to slope away from the building are recommended. Add a clay type soil surrounding the structure wherever possible on the perimeter up to 2 ft away from the foundation to help prevent moisture infiltration into the foundation.

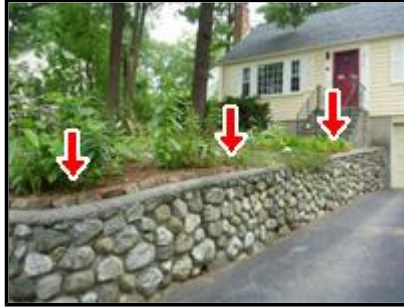
3.0 Picture 5

(4) **RR:** The retaining wall on the side of the driveway has no guardrails in place. This condition is a safety

hazard because someone could fall from this area into the driveway. Installation of guardrails is recommended in these areas.

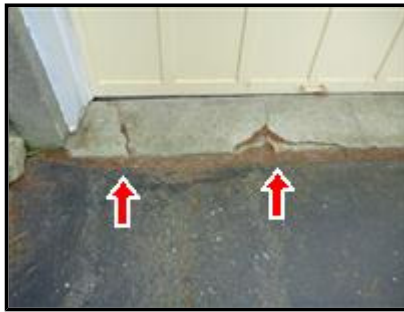
3.0 Picture 6

(5) **RR:** There are cracks in the concrete portion of the driveway near the door. When water penetrates these cracks it can cause them to worsen, and weed growth can cause damage, and moisture accumulation can cause heaving. It is recommended that this section of the driveway be patched (temporary repair) or replaced (preferred repair).

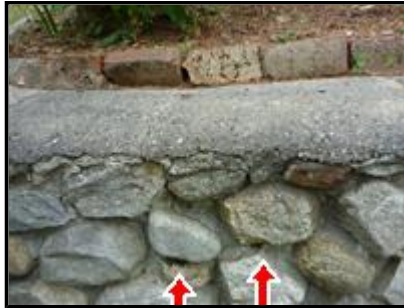
3.0 Picture 7

(6) **FR:** There are minor areas of mortar cracking. Expect to re-point these areas in the near to medium term.

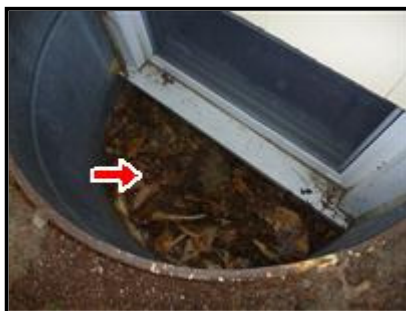
3.2 Picture 1

MR: There is dirt at the bottom of the window wells. This prevents drainage of the wells. Add gravel at the bottoms of the window wells to allow for drainage of the wells. Remove leaf debris and dig down to 6 inches below the bottoms of the sills. Add 2 inches of gravel on soil so that bottom of basement window sill is approx. 4-6 inches above gravel.

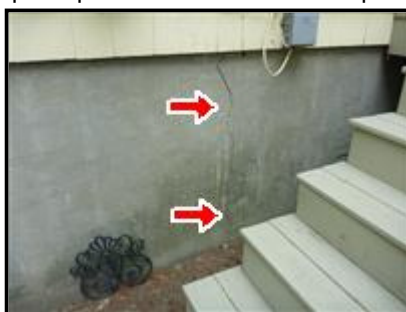
3.3 Picture 1

RR: There is a crack on the exterior of the foundation on the right side of the home. This condition can cause moisture or insect infiltration and may worsen over time. This crack should be sealed on the exterior and interior. Consult a foundation crack repair specialist or mason for repairs.

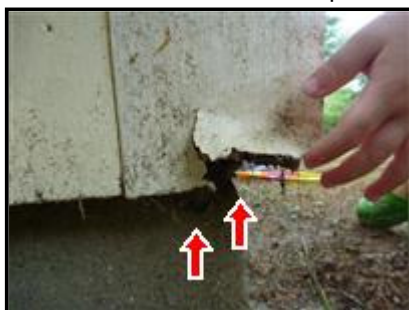
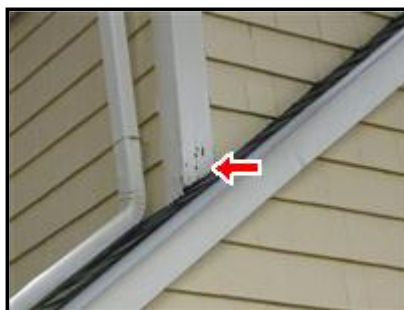
(1) **RR:** There is rot to the corner boards on the left rear of the home. These rotted sections of corner board should be replaced. Consult a contractor for repairs.

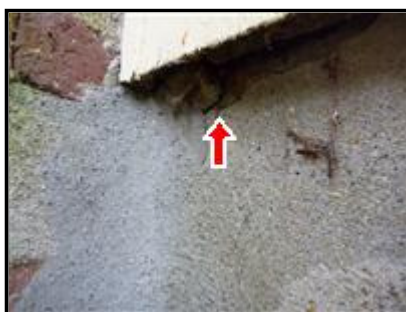
3.4 Picture 3

(2) **RR:** There is a gap in the siding at the bottom edge on the left side of the home next to the chimney. Sealing this hole is recommended.

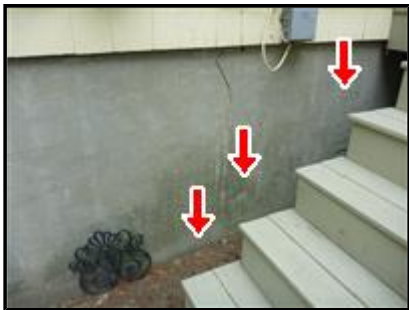
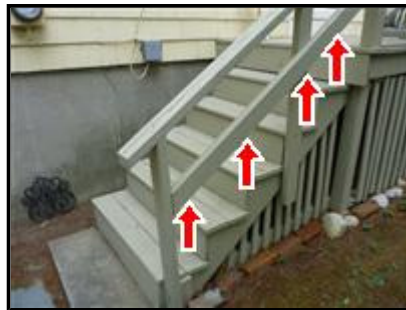
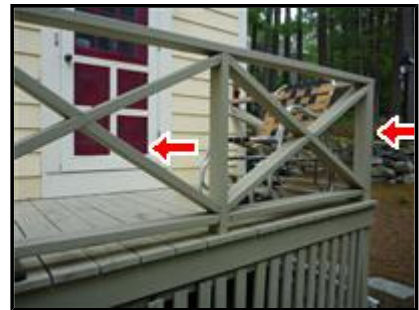
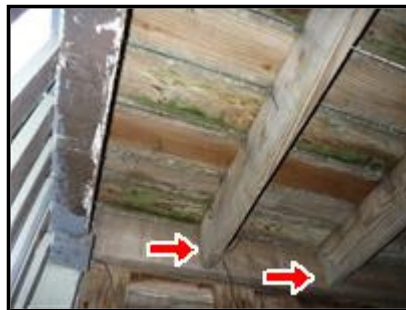
(1) **RR:** The handrail in place on the right side stairs has no baluster system. This condition can allow children to fall through the sides of the stairs. Replacement of the railings on the stairs with railings that have vertical balusters is recommended. Consult a contractor for repairs.

RR: The railings on the right side stair platform/deck do not have proper balusters. The guardrail and railing is constructed of horizontal components. This creates a ladder effect. Children can climb up the railing and fall. It is recommended that the railing be repaired or replaced with proper vertical balusters. The space between each baluster should be such that a sphere 4 inches in diameter cannot fit through.

RR: There is a space between the stairs to the right side entry and the foundation wall/siding on the home. This is a falling hazard. It is recommended that you install a handrail on this side of the stairs or replace stairs with stairs that are built to run up against the home.

RR: There are no joist hangers for the joists under the deck. Joist hangers are recommended to provide additional support for the decking. Without these, the joists may become loose and could fail. Installation of hangers is recommended.

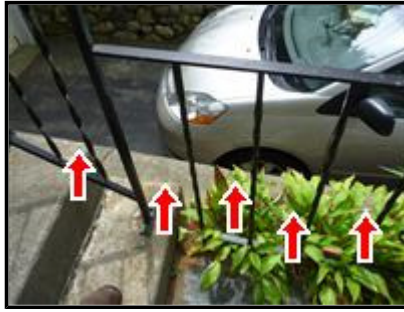
3.6 Picture 5

(2) **RR:** The spacing of the balusters for the front stair and path guardrail and handrail is too far apart. This may allow a child to climbing or fall through, or get their head stuck in the guardrail. Ideal spacing is such that a sphere 4 inches in diameter cannot fit through any gaps in the railing components. This condition should be corrected. Consult a contractor for repairs.

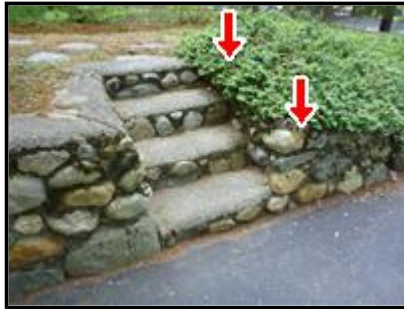
3.6 Picture 6

(4) **RR:** There are no handrails on the right side exterior steps. This condition can be a falling hazard. Installation of handrails is recommended.

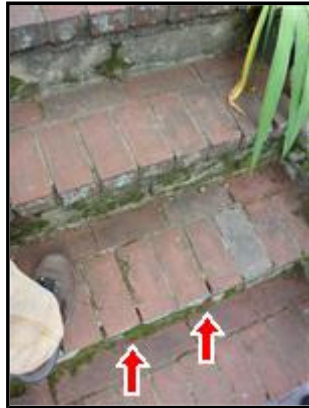
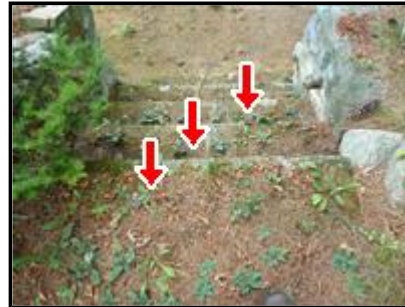
(5) **RR:** The front steps to the street have some open mortar joints, and the rear yard stairs have open tops to the treads, which are made of masonry block. This condition can lead to further moisture damage, and is also a safety hazard because the stair treads are not smooth and even. Repairs are recommended. Pointing is recommended to the front steps, and addition of treads on the rear steps is recommended. Consult a mason for repairs.

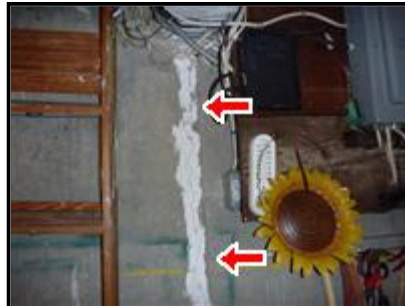
4.0 Picture 1

(1) **RR:** There is a vertical crack in the concrete on the right side of the foundation (in the garage area of the home). This type of crack is typical for a home of this type and age. The crack should be sealed to prevent moisture and insect infiltration. Consult a foundation crack specialist for repairs. Foundation cracks should also be monitored for further movement or opening. If any changes are noted, a licensed engineer should be consulted for further investigation.

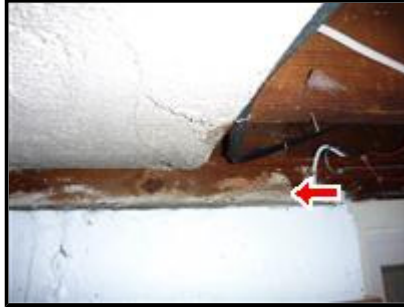
4.3 Picture 1

(1) **FI:** There is insect damage on the left side of the home in the sill. This damage appears old and the sill is hollow in the area of the damage. There is a concern that there could be additional damage to the sill in the areas to the front of the damage and potentially to the main beam. These areas were not able to be inspected because they were concealed by plaster. It is recommended that the concealed sections of sill and beam be uncovered and the structural components be inspected in these areas.

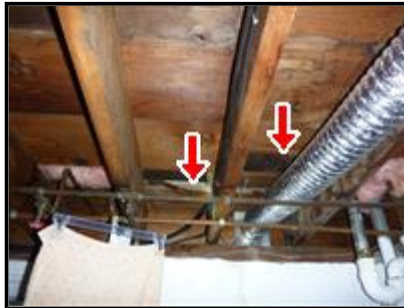
4.3 Picture 2

(2) **MR:** There are holes around pipes and wires and/or open gaps in the subfloor for the flooring in the first floor. Sealing these holes and patching these gaps is recommended to help prevent air, insect, and rodent infiltration up into the home. Consult a handyman or other qualified person to repair this condition.

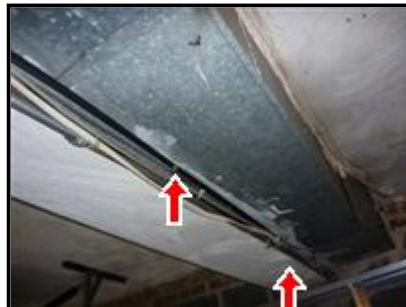
5.3 Picture 1

(2) **Energy Efficiency Upgrade:** There is no insulation on the supply ducting in the basement and the garage. This can make the heating system operate less efficiently than one with insulation on the supply ducting. Adding insulation is recommended.

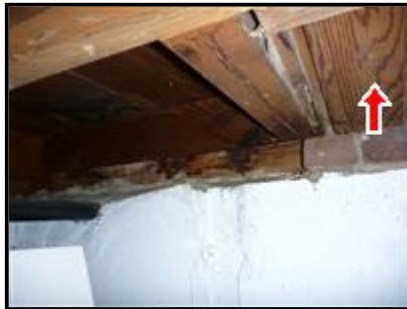
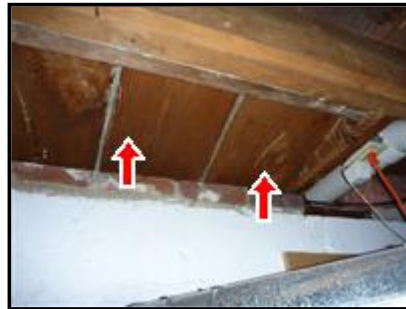
(1) **RR:** The form boards for the hearth extension are still in place under the fireplace chimney hearth extension in the basement. These form boards are meant to be removed after the hearth extension is built because they are a fire hazard in the case that embers fall through any cracks that may form in the hearth or hearth extension. Removal is recommended. Consult a chimney sweep for repairs.

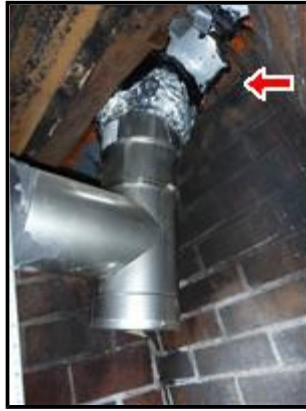
5.6 Picture 1

RR: There is a wood stove currently installed in the fireplace. This stove may or may not be staying. Verify if staying or not. Also, there is a direct connection between the stove and the fireplace flue. The damper has been modified for use with the wood stove. The interior of the flue was not visible for inspection due to this condition, and the damper will require rebuilding or replacement if the stove is removed. Consult a chimney sweep for repairs to be able to burn wood normally in the fireplace if stove is removed.

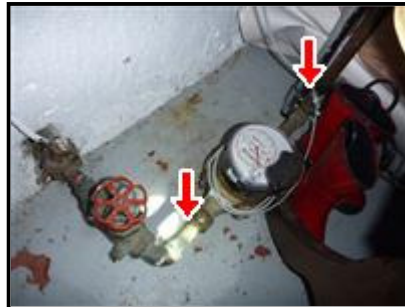
6.1 Picture 1

(1) **RR:** There is no bonding jumper wire over the water meter. This wire connects from the street side to the house side of the meter and connects the grounding system to the house side of the plumbing system. This wire is recommended. Consult licensed electrician for repair.

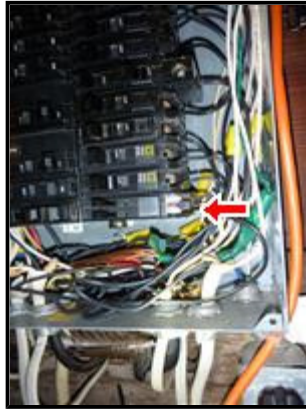
6.1 Picture 2

(2) **FI:** There are mini-breakers in use in the subpanel in the unit. The panel schematic does not indicate that the panel is designed for use with mini-breakers. Further investigation by an electrician is recommended, with correction as necessary.

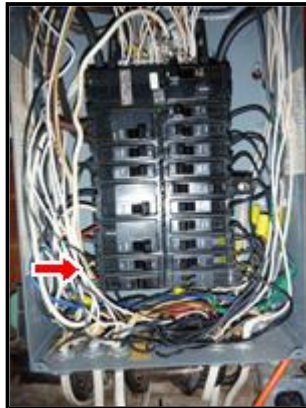
6.3 Picture 1

(1) **RR:** There are three circuits installed on one breaker in the main panel. This is a safety hazard and should be corrected. Circuit breakers may only have a maximum of two wires attached to the lugs if allowed by the manufacturer, and most are only rated for use with one circuit. Consult an electrician for repairs.

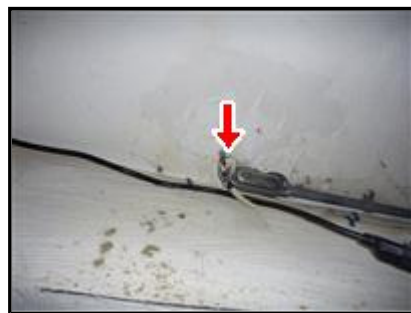
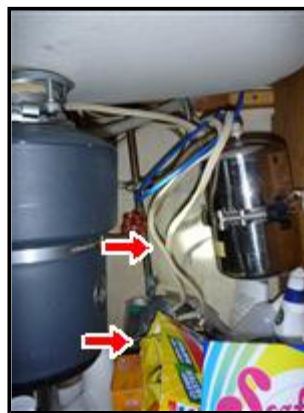
(2) **RR:** There is some wire sheathing that is taped with electrical tape on the outside of the wire. The extent of any damage to the wire is not known. remove tape in this area and replace feed wire if necessary. Consult an electrician for repairs.

RR: The wiring for the appliances under the sink is unprotected romex wiring, and the junction box is floating loose in the cabinet. This is a safety hazard. Properly mount junction box and replace exposed romex wiring with flexible armored wiring. Consult an electrician for repairs.

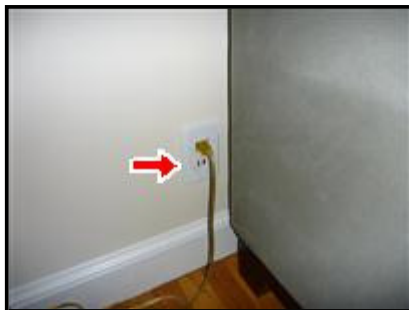
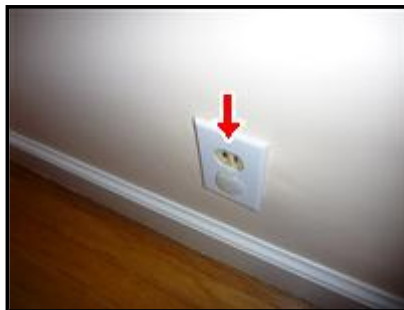
(1) **RR:** There are older two prong ungrounded receptacles in living room, dining room, and bedroom areas. Upgrade is recommended. Replacement with grounded wiring or replacement of aged two prong receptacles with GFCI receptacles is recommended. Upgrade to grounded circuits in rooms or areas where you intend to use appliances that require ground. Consult electrician for repairs.

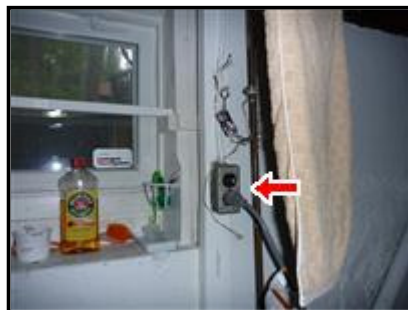
6.6 Picture 3

(3) **RR:** Upgrade unfinished basement and laundry area receptacles to GFCI is recommended. Consult electrician.

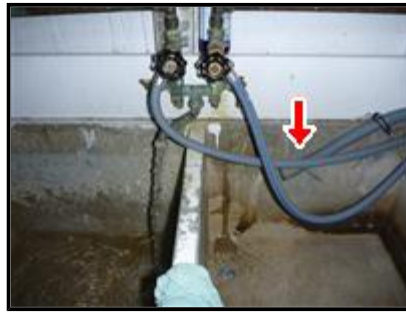
7.0 Picture 1

- (1) **FR:** The main waste piping is aged cast iron. This piping is at or very close to its average life expectancy. It is not possible to predict the remaining life of this piping. You should expect that you may have to make repairs or replacements in the near future. Monitor for deterioration and/or leakage and repair as necessary.
- (2) **RR:** The basement utility area for laundry is set up so that a washer will need to drain into the laundry sink. This is not recommended. It is recommended that a dedicated, properly plumbed standpipe be installed for washer drainage.

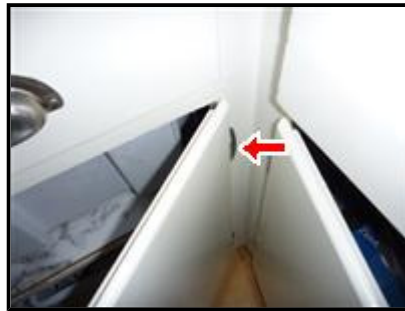
9.3 Picture 1

MR: Fill and seal holes around pipes under sink.

MR: Secure and adjust loose hinges on cabinet doors.

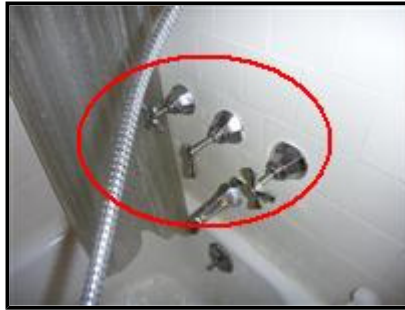
10.0.A Picture 1

(1) **RR:** Replacement of older hot and cold isolated shower/tub control valves with antiscald valve conversion kit is recommended. Consult plumber for repair/upgrade.

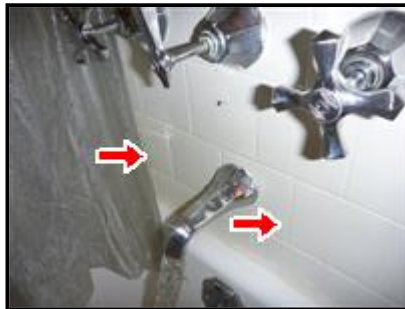
10.1.A Picture 1

RR: There was a hollow sound in places on the wall in the shower and the wall feels soft in places. There may be additional damage, mold, rot or deterioration to the framing and wall board behind the tile in this area. Repair is recommended. Keep in mind that if the damage is too extensive, then retiling the wall may be necessary. This is often the case when there is old deteriorated wallboard or plaster behind tile.

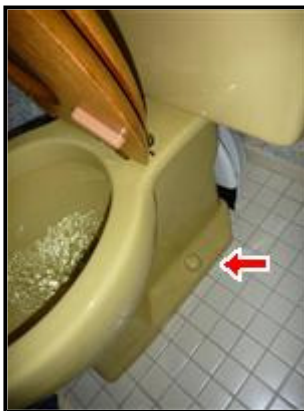
10.0.B Picture 1

(1) **RR:** The toilet is loose in the floor. Repairs may involve re-setting the toilet on a new wax seal or repairs to the flange. Consult a plumber for repairs.

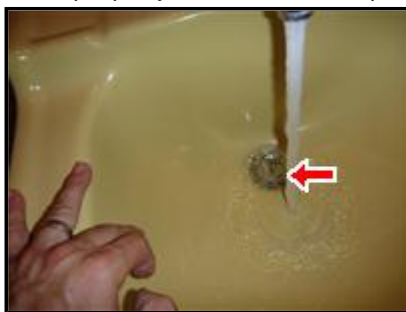
10.0.B Picture 2

(2) **RR:** The tub stopper valve did not operate. Repair recommended. Consult plumber.

(3) **RR:** The sink stopper did not operate properly when tested. Repair/adjust.

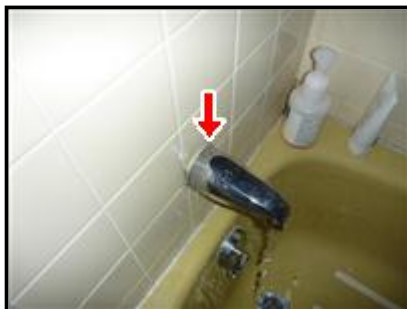
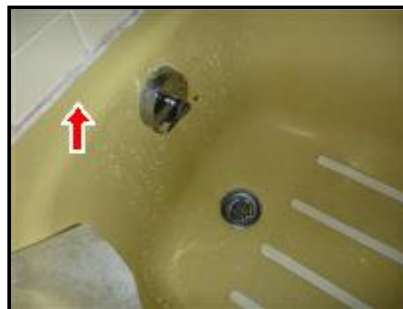
RR: Scrape and reseal caulking between tub and walls, and caulk the joint between the tub spigot and the wall.

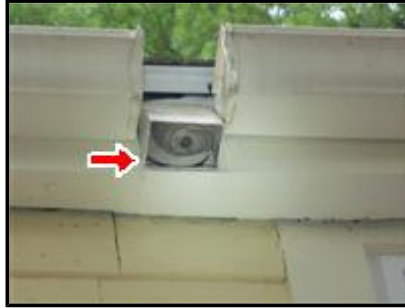
10.3.B Picture 1

RR: The bath exhaust vent fan outflow hood is blocked by a bees nest. This prevents the flap from opening and is a safety hazard. It is recommended that the bees nest be removed. It is not known whether or not this nest is active. No bees were observed in this nest or in the area of the nest (The nest may still be active, though). Consult a pest control operator for removal of the nest.

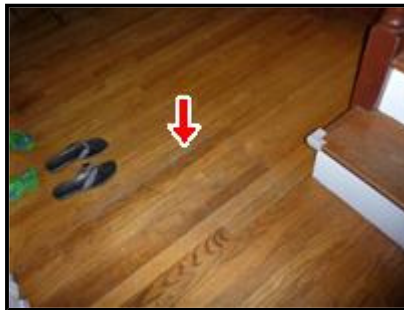
11.2 Picture 1

RR: There is surface damage, wear and cupping to wood floors in the home. Refinishing the floors is recommended.

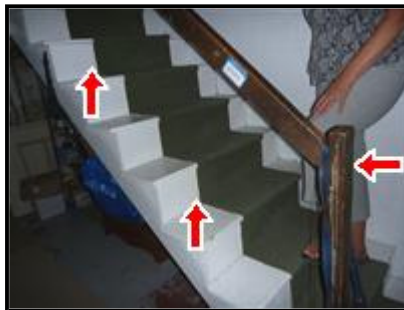
11.3 Picture 1

RR: It is recommended that you add vertical balusters to the stairs to the basement on the open side of the stairs, and secure the basement handrail. Consult a contractor for installation.

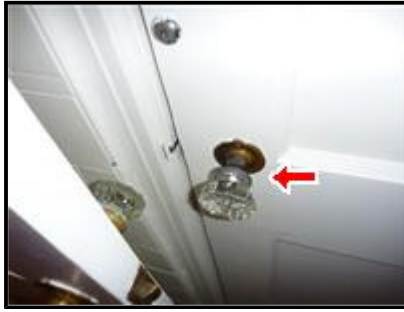
11.4 Picture 1

RR: There are older doors and door hardware throughout the building. Some latches do not line up and require adjustment. Some hardware is loose and requires repair or replacement. Consult a carpenter to repair and adjust doors in the home to operate properly.

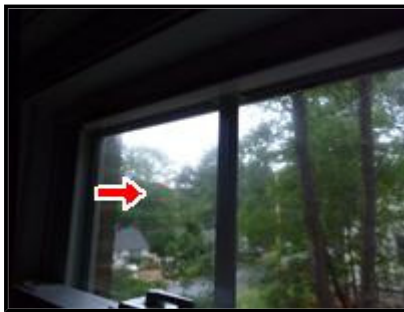
11.5 Picture 1

RR: The top sash on the left side second floor window has a thermal seal failure. This condition is evident due to condensation and staining between the panes of glass. This condition causes the window to become fogged. This sash should be reglazed or replaced.

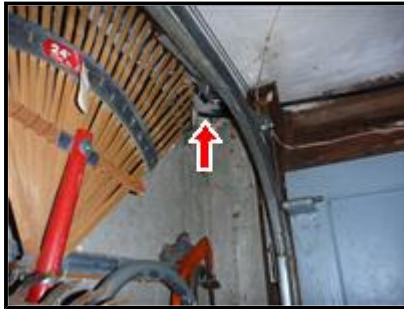
12.0 Picture 1

MR: There is a small hole in the ceiling in the garage above the door on the right side (right front corner). Fill and seal with a fire rated caulking.

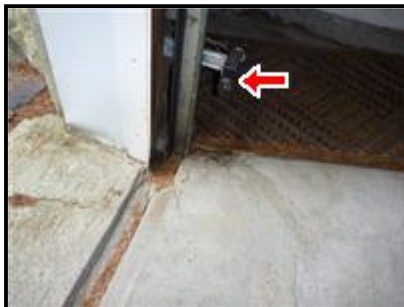
12.4 Picture 1

(1) **RR:** The opener has electronic sensors located higher than six inches off floor which may not be installed according to manufacturers specification. Most door manufacturers state that sensors should be mounted 6 inches or lower from the floor. This is unsafe and needs correcting.
